Beaufort Gyre Exploration Project: Dispatch 7: You Down With ITPs? Yeah You Know Me

Alex Kain
September 23, 2009

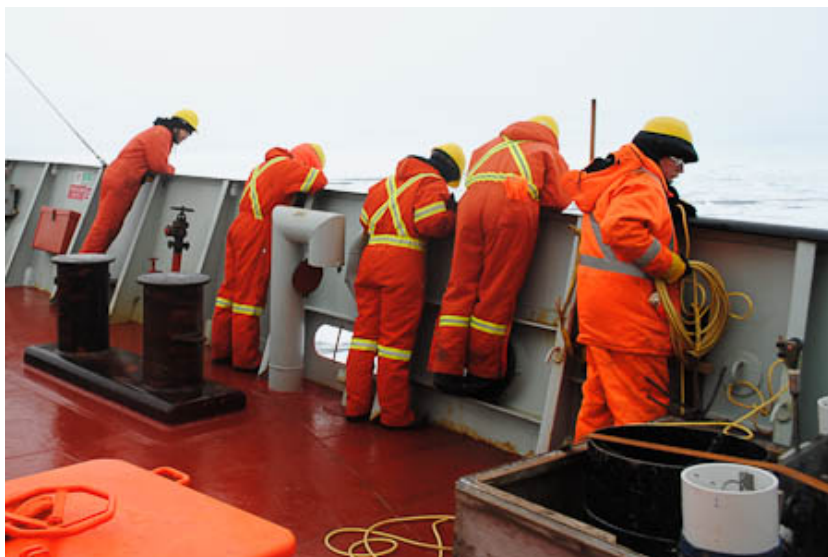
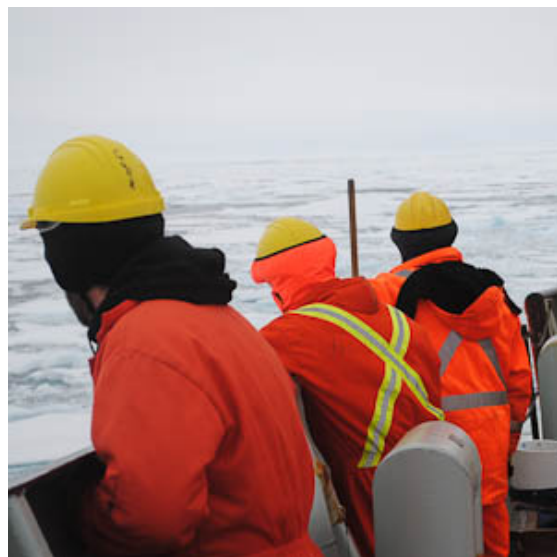
Crew members look over the side of the ship hoping to spot the ITP hiding in a sea of ice.

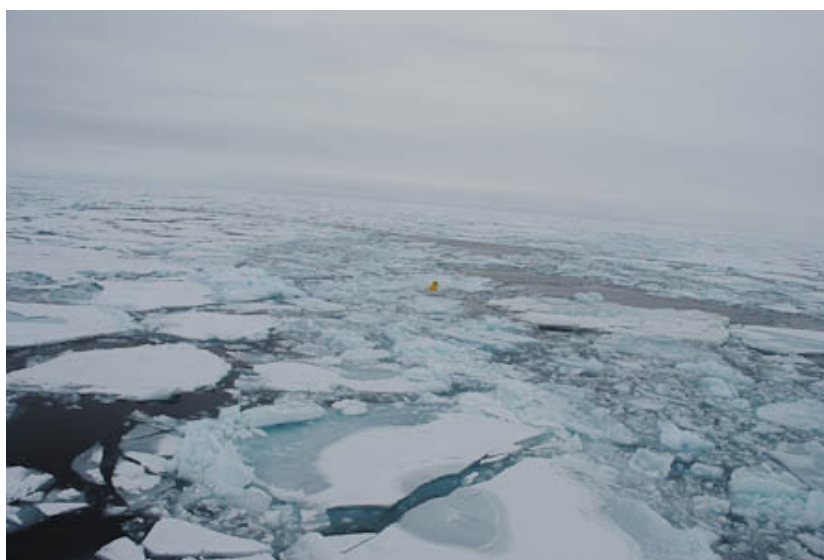
Success! After several attempts to break up the floes covering the ITP, the profiler emerged among battered ice cubes. With the ITP freed, crew members and WHOI scientists could begin the mooring retrieval.

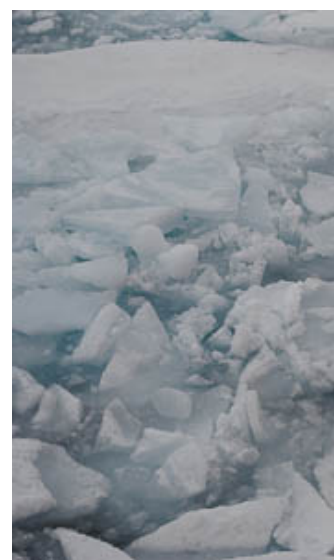
Once the ship was positioned next to the ITP, a crane was used to pull the ITP out of the ice. The hook keeps the crane into position.

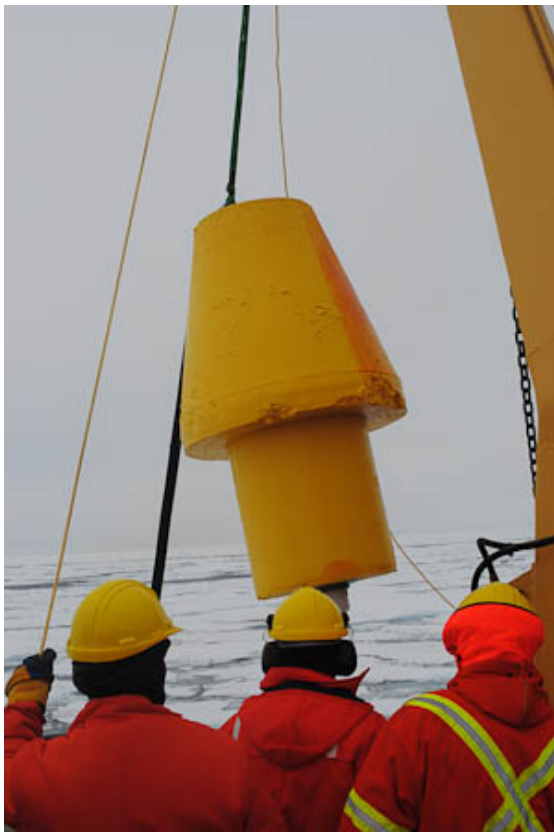
Crew members stand ready to guide the ITP to the deck. While ramming ice to break up floes, the hull of the ship scraped against the float, leaving a red stripe on its side.

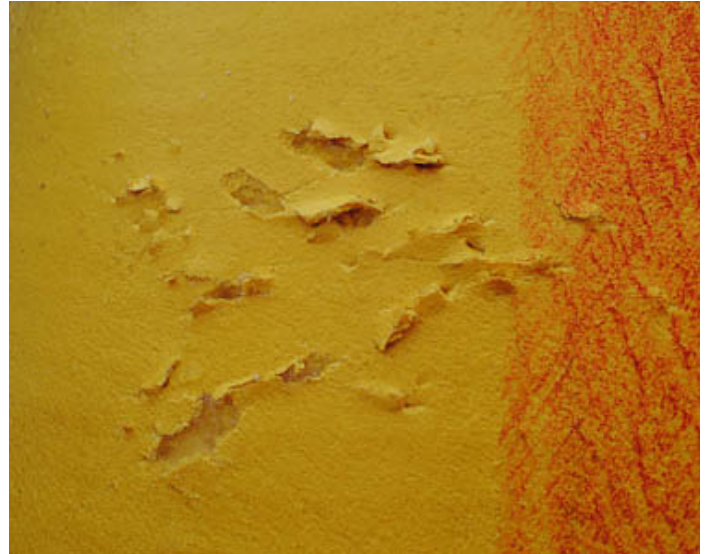
Looking like a vandalized Rothko painting, the ITP float showed signs of attack.. Some polar bear in the Beaufort Sea is probably very disappointed the mooring float is not made of beluga meat.

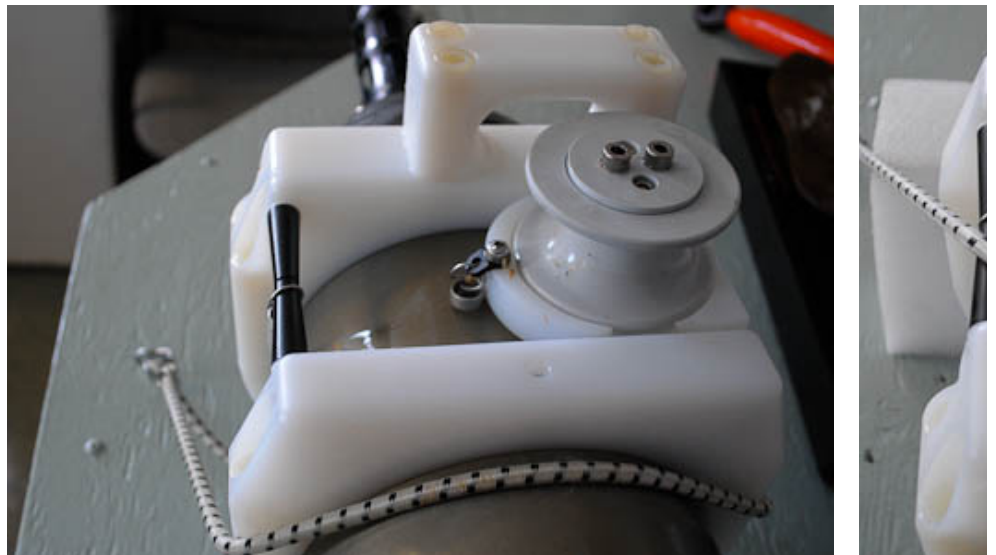
With the mooring on deck, scientists could begin determining why the ITP stopped functioning. Early hypotheses were that it had suffered some damage. A spring meant to hold the profiler's motor against the 700 meter line had snapped, causing the profiler to sink to the bottom of the line.

The right picture shows a fully functional wheel portion of the ITP with its spring intact. The left photo shows the float after colliding with a floe. WHOI engineers will account for this design flaw while developing the next generation of ITPs.
