Beaufort Gyre Exploration Project: Dispatch 9: Mooring Day

Will Ostrom
August 13, 2006

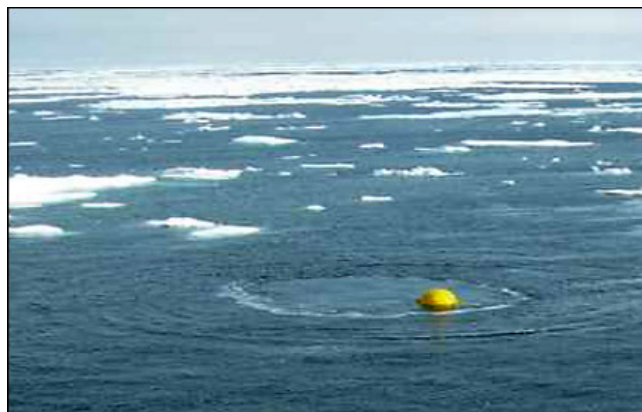
The surface floatation package arrives at the surface exactly where expected.

At noontime we arrived at the site. The ship's position relative to where the mooring would surface was critical. The desire was to have it come up approximately 20 m (65 ft) off the ship's starboard bow. With excellent ship handling from Captain Andrew McNeill on the bridge, the mooring came up just where it was expected. The mooring's bottom end with several 17" glass flotation spheres soon arrived on the surface. The ship then maneuvered alongside the large sphere and hooked it with the crane. The sphere was unshackled from the mooring wire and stowed on deck. The Lebus winch was then brought into play, winding up the wire rope through a block hung in the A-frame. The scientific instruments on the wire were removed, and the remainder of the mooring was recovered with the ship's crane. The deck operations were completed in only 35 minutes from start to finish, and then it was time to open the instruments and see what information was collected for the past year.

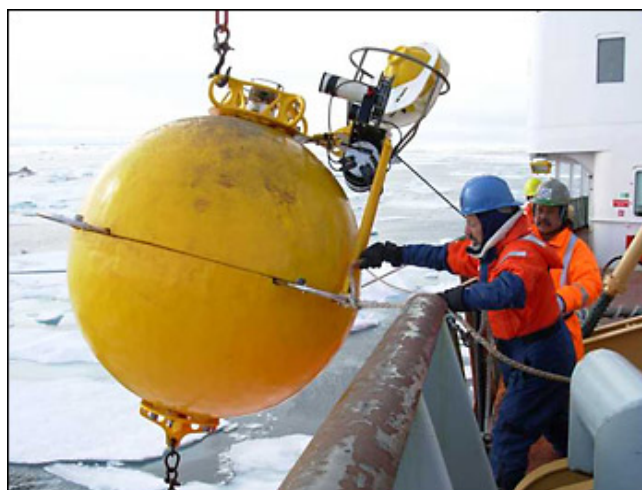
The ship's crane wire hooks to a lifting eye on the sphere.

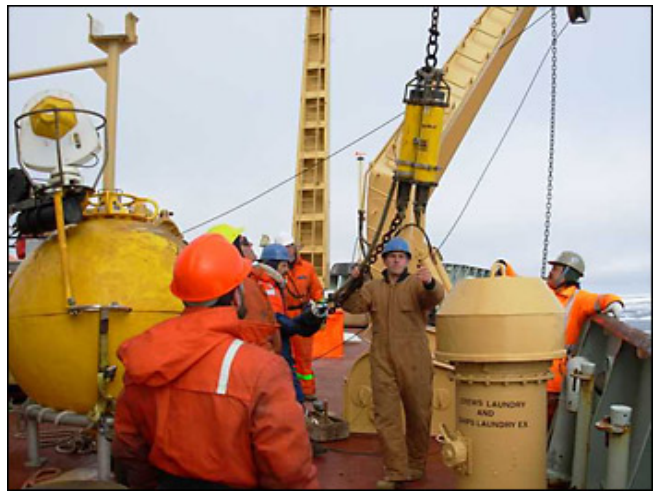
Kris Newhall tending to his releases which were the last gear to be recovered.

In seawater only 147 m (480 ft) deep, the mooring's mechanical design consisted simply of a large floatation sphere at the top, an 85 m (280 ft) long length of wire rope, several glass flotation spheres, and an acoustic release attached to a large anchor. Attached to the top of the sphere was a profiling winch system to measure the seawater properties above the sphere, and a sonar instrument which determined the thickness of the ice drifting overhead. Oceanographic instrumentation attached to the mooring measured ocean temperatures, salinities, currents and direction over the previous year, and sea level variations from bottom pressure measurements. All this data was recorded internally, so it was necessary to recover the mooring to obtain the results. To read about the scientific objectives of the Beaufort Slope project visit the [Arctic Edge website](#).
