Beaufort Gyre Exploration Project: Dispatch 9: Mooring Day

Will Ostrom
August 13, 2006

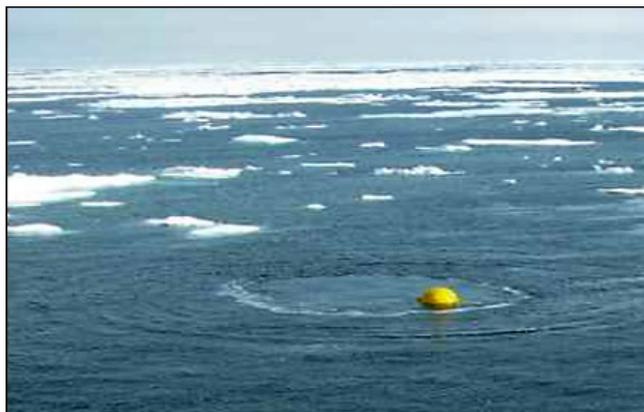
The surface floatation package arrives at the surface exactly where expected.

At noontime we arrived at the site. The ship's position relative to where the mooring would surface was critical. The desire was to have it come up approximately 20 m (65 ft) off the ship's starboard bow. With excellent ship handling from Captain Andrew McNeill on the bridge, the mooring came up just where it was expected. The mooring's bottom end with several 17" glass flotation spheres soon arrived on the surface. The ship then maneuvered alongside the large sphere and hooked it with the crane. The sphere was unshackled from the mooring wire and stowed on deck. The Lebus winch was then brought into play, winding up the wire rope through a block hung in the A-frame. The scientific instruments on the wire were removed, and the remainder of the mooring was recovered with the ship's crane. The deck operations were completed in only 35 minutes from start to finish, and then it was time to open the instruments and see what information was collected for the past year.

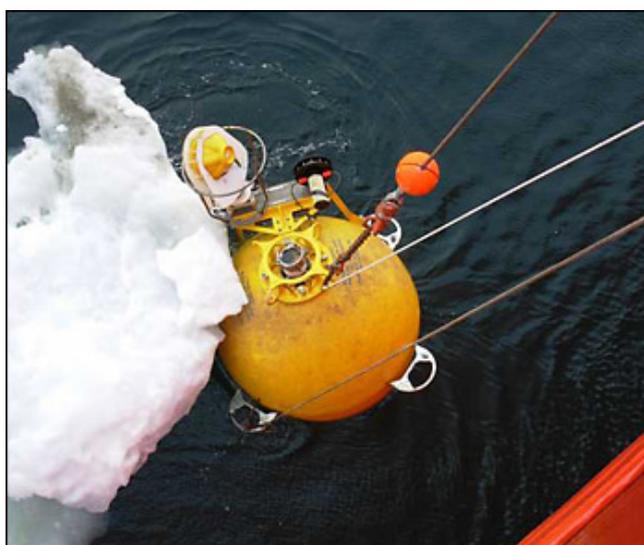
At the ship's rail, Will Ostrom and Bosun Rico Amamio secured handling lines to the sphere.

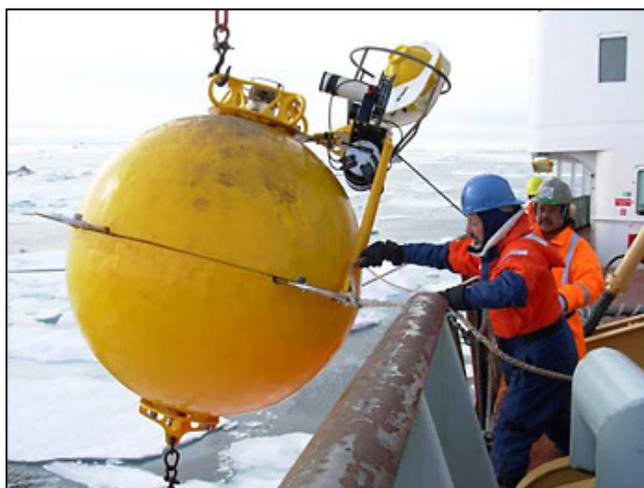
The ship's crane wire hooks to a lifting eye on the sphere.

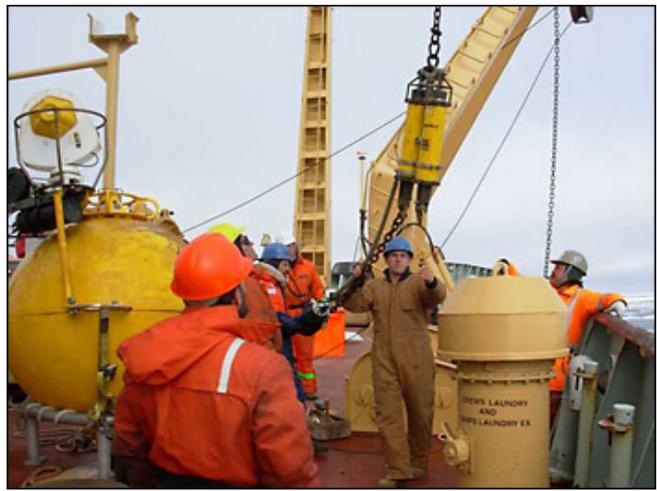
Kris Newhall tending to his releases which were the last gear to be recovered.

In seawater only 147 m (480 ft) deep, the mooring's mechanical design consisted simply of a large floatation sphere at the top, an 85 m (280 ft) long length of wire rope, several glass flotation spheres, and an acoustic release attached to a large anchor. Attached to the top of the sphere was a profiling winch system to measure the seawater properties above the sphere, and a sonar instrument which determined the thickness of the ice drifting overhead. Oceanographic instrumentation attached to the mooring measured ocean temperatures, salinities, currents and direction over the previous year, and sea level variations from bottom pressure measurements. All this data was recorded internally, so it was necessary to recover the mooring to obtain the results. To read about the scientific objectives of the Beaufort Slope project visit the [Arctic Edge website](#).
