**The Beaufort Gyre Observing System 2004:  
Mooring Recovery and Deployment Operations in Pack Ice**

Woods Hole Oceanographic Institution  
Technical Report WHOI-2005-05

## Abstract

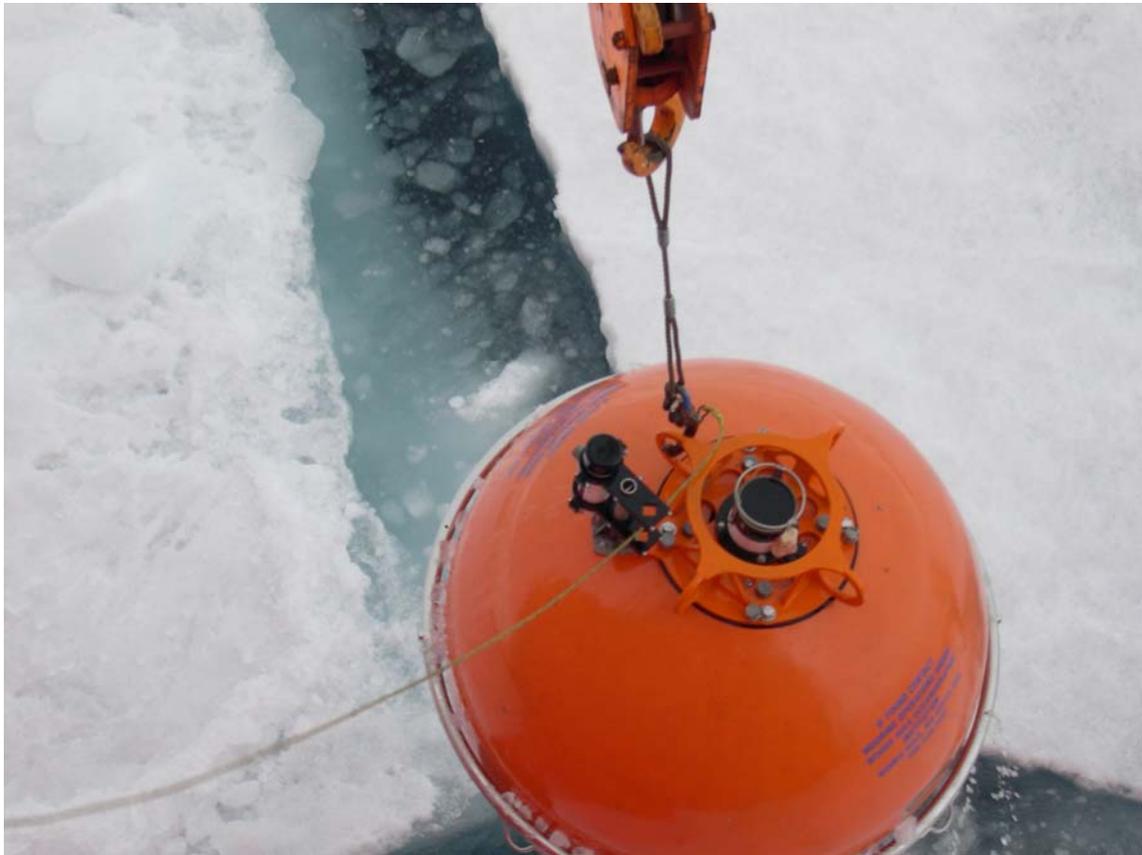
Figure 5. Top flotation sphere being recovered using the ship's crane.

The recovery hook was suspended on a 3-meter wire pennant from the block on the crane. Once the mooring sphere had surfaced, the Captain maneuvered the ship to a point where the sphere was directly under the position of the cranes on the fore deck. The open ended hook was lowered and skillfully positioned using the steering tag line into the pickup point on the sphere (Figure 5). Once hooked, the sphere was hoisted up out of the water. This hooking method relied on skillful coordination between the person steering the recovery hook and the crane operator but proved to be a reliable and a less time consuming method of retrieving gear out of the water in ice covered conditions.

Once hoisted out of the water, the crane maneuvered the sphere into a position directly under the A-frame. A vertical chain stopper with a safety hook attached to the bitter end (previously suspended from a pad eye on the A-frame) was then snapped into a sling link (disconnect point) under the sphere. The load was then transferred to the chain stopper, and the buoy was disconnected and craned to a position on the deck of the ship where it was secured.

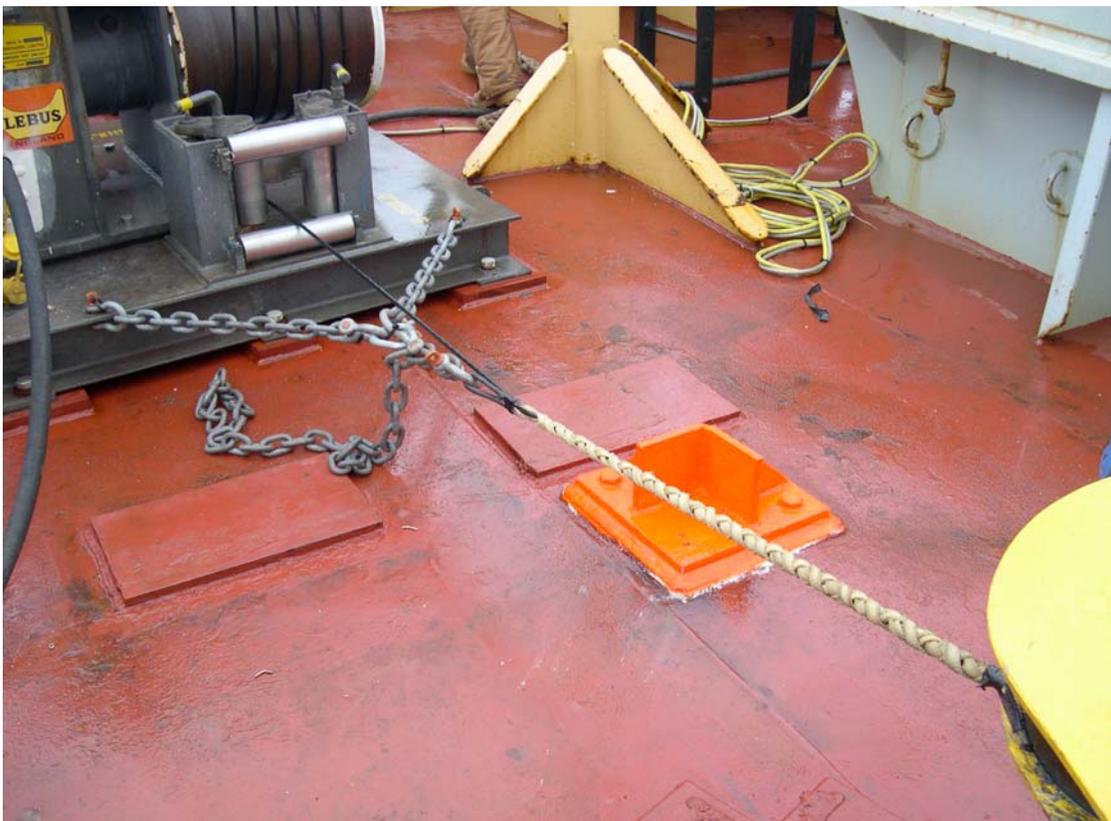
Figure 6. Wire rope section secured using a Kevlar “Yale” grip. This procedure was used to remove tension from the traction drums when changing reels on the traction winch spooler.

The traction winch tag line was then shackled into the stopped off sling link and the winch then took the load of the mooring so the vertical chain stopper safety hook could be removed. At this point, the mooring wire was hauled up far enough for the removal of the upper MMP bumper stop. Once the bumper was removed, the winch began hauling in the first shot of 1995 m of 5/16" wire rope. When the termination of the first shot of wire rope reached the winch, a preassembled 1/2" chain bridle shackled to the winch base was used to secure it, and the load was transferred to a "Yale Grip" which

was shackled to the chain bridle, thus taking all the weight away from the winch drums (Figure 6).

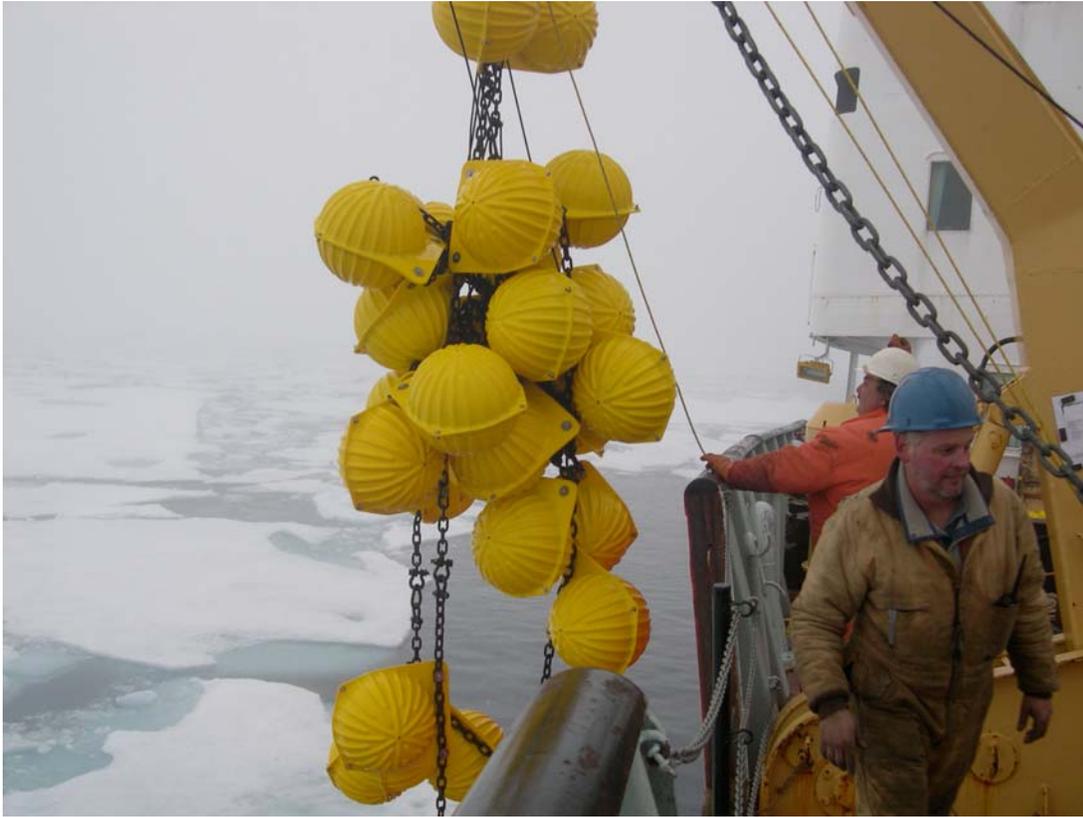
Figure 8. Cluster of glass floats comprising the backup buoyancy being recovered.

The glass spheres also snarled in large bunches (Figure 8) and sometimes were wedged just underneath the ice. In order to recover the spheres without putting too much strain on the wire, it was decided to slowly pay in the winch while the ship slowly traveled toward the direction of the wire. In other words, the captain went to the spheres instead of trying to pull the spheres to the ship. This method proved to be extremely effective and necessary in order to recover this section of the mooring safely. Because of the enormous snarls, the spheres were literally caught up in the ice and required a vertical lift instead of a horizontal drag.

When the floats were reached, an open-end recovery hook and steering tag line was used to attach to the cluster. The ship's crane was lowered, and the Boatswain hooked onto a link of chain, a shackle, or a pear ring, then raised the cluster to the A-frame. The vertical chain stopper was used to hook into a termination of wire below the balls in order to stop off the mooring so the floats could be disconnected and brought onto the deck.

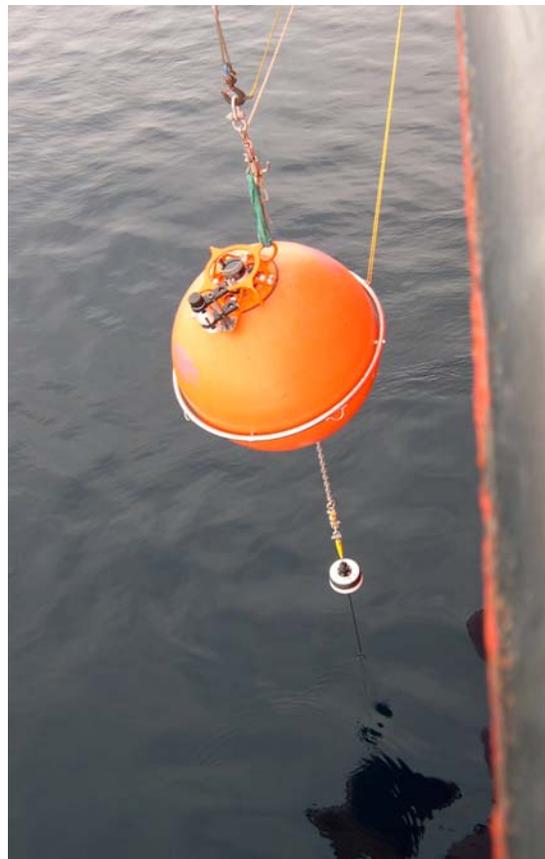
Figure 9. Top sphere deployment.

Once all the instruments and wire were in the water, the last piece of the mooring to be deployed was the 64" Syntactic sphere with a ULS and an acoustic transponder mounted to the top. A release hook was secured to the top bail of the sphere using a 'Lift-All' sling then attached to the ship's crane (Figure 9).

The crane then lifted the sphere outboard of the A-Frame and the mooring was attached to the 1 m shot of ½” Trawler Chain. The crane took the load from the vertical chain stopper so it could be removed. The top sphere was held at the surface of the water, but before being released, an acoustic range was conducted on one of the releases. About a minute after releasing the top sphere, the mooring settled at the bottom, and more ranging was conducted.
